Coseismic and monsoon-triggered landslide impacts on remote trekking infrastructure, Langtang Valley, Nepal

Quarterly Journal of Engineering Geology and Hydrogeology

J. N. Jones, M. Stokes, S. J. Boulton, G. L. Bennett & M. R. Z. Whitworth

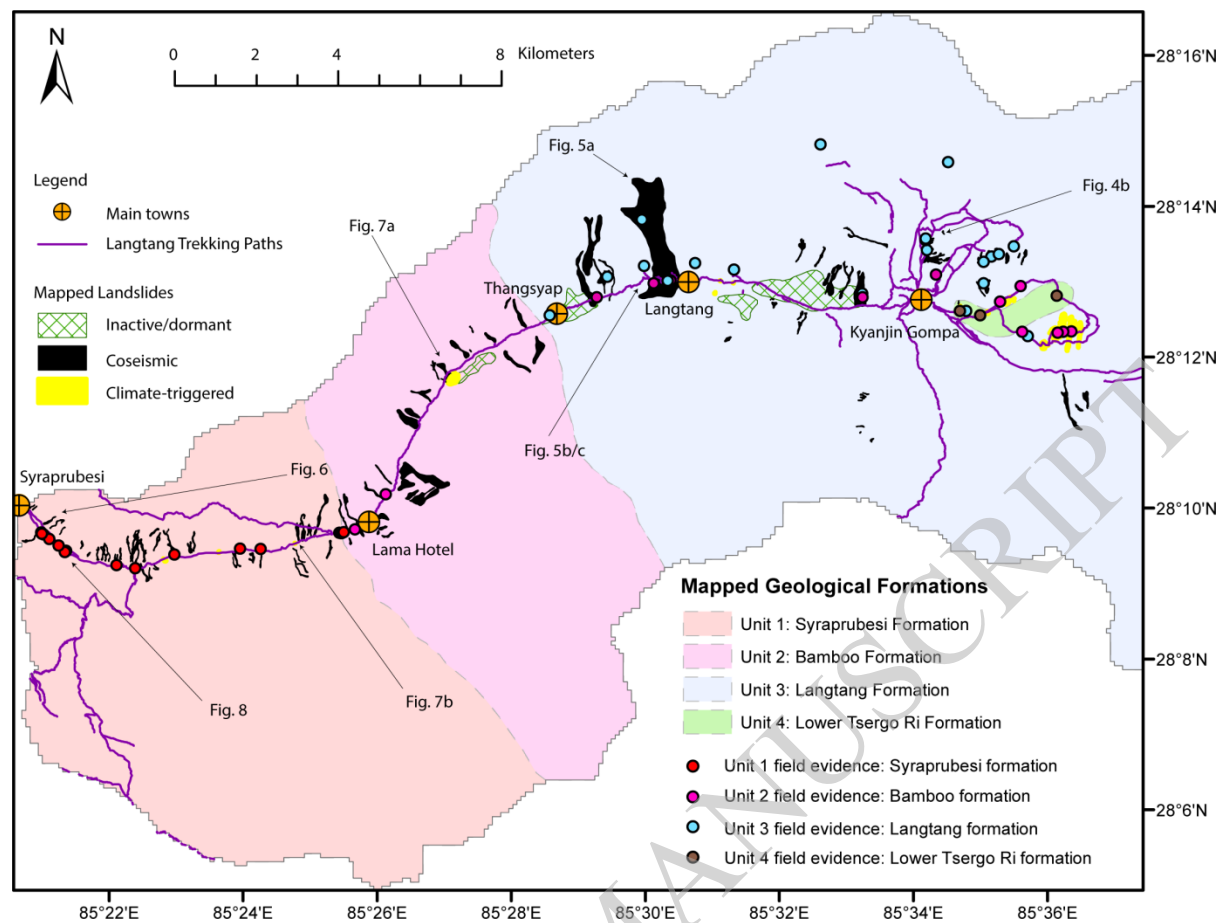
Fig. 2. Map of the lower portion of Langtang Valley that was the focus of the fieldwork. The main geological unit observations and estimated extents, towns, trekking routes and mapped landslides are displayed. The locations of the landslides in figures 4-8 are also highlighted.

Field data collection occurred along the main trekking routes in Langtang Valley between Syapruwesi and Kyanjin Gumpa, a total distance of approximately 50 km (Fig. 2). An inventory including both

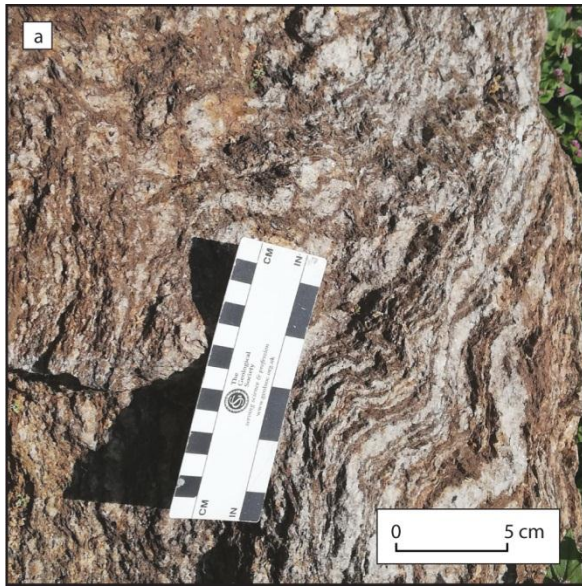
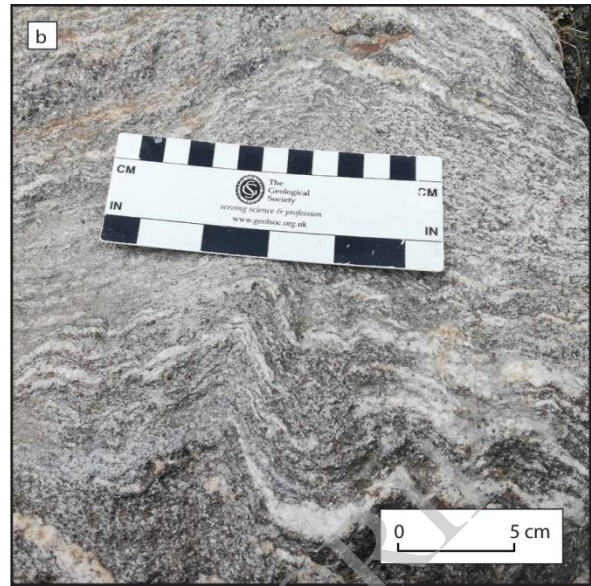
Fig. 3. (a) Example material of unit 1, a muscovite, biotite, plagioclase, quartz, garnet gneiss, termed here as the Syraprubesi Formation. Note the strong mylonitic fabric. **(b)** Example material of unit 2, a muscovite, biotite, plagioclase, quartz, tourmaline gneiss, termed here as the Bamboo Formation. Again, note the strong mylonitic fabric, and the dominance of quartz and biotite.

Four lithological units were identified within landslides across the valley. The first unit, termed here as the Syraprubesi Formation, is a gneiss dominated by muscovite, biotite and quartz, with subordinate components of plagioclase and garnet (e.g. Fig. 3a). This unit is medium- to coarse-grained, with average grain size of 0.3 – 3 cm. The minerals were generally platy, with elongated

plagioclase orientated parallel to foliation and a strong mylonitic fabric. *In-situ* strength tests indicate that this unit is hard (50 – 100 MPa). The second unit, the Bamboo Formation, is a gneiss dominated by muscovite, biotite and quartz, with subordinate components of tourmaline (e.g. Fig. 3b). This unit was very similar to unit one, but with a larger average grain size of 1 – 3 cm, and with the addition of tourmaline. Unit two had a much higher proportion (60 – 70 %) of quartz and biotite compared to unit one, but maintained the mylonitic fabric. Strength tests suggest that unit two is very hard (100 – 250 MPa). Unit three, named the Langtang Formation, is a coarse-grained (2 – 6 cm) leucogranite, dominated by muscovite, tourmaline, epidote, and occasionally garnet (e.g. fig. 4a). Unit three was commonly found intruded into units two and four, and has a strength of 50 – 250 MPa. This unit was often observed in the source zones of earthquake triggered rockfalls (e.g. fig. 4b). We hypothesize that the discontinuities induced by the intruded leucogranite dykes and sills have reduced the shear strength of the bedrock, making failures in regions with this unit more likely. Unit four, termed here the Lower Tsergo Ri Formation, is a biotite, plagioclase, muscovite, quartz, semi-pelite schist (e.g. fig 4c). This unit was finer grained than the other units (average grainsize 0.25 – 1 cm) and had an estimated strength of 100 – 250 MPa. This unit was dark to light grey in colour and was frequently observed to be in contact with leucogranite.

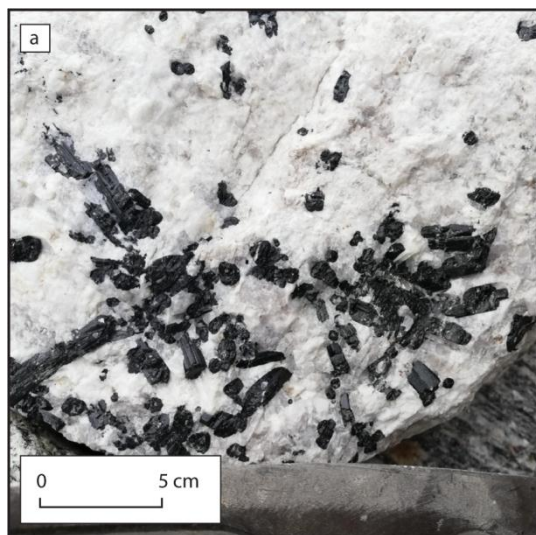
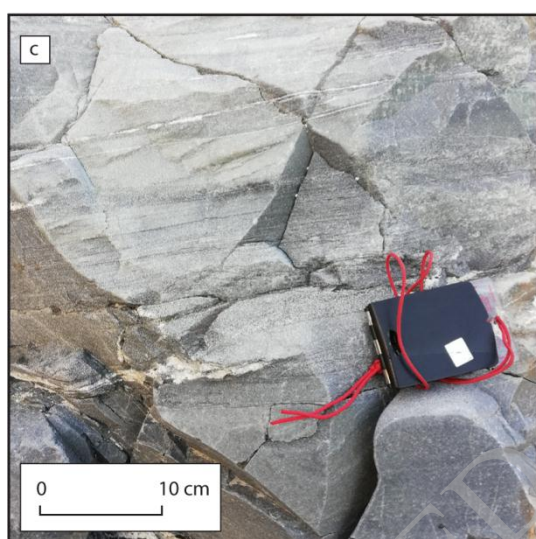
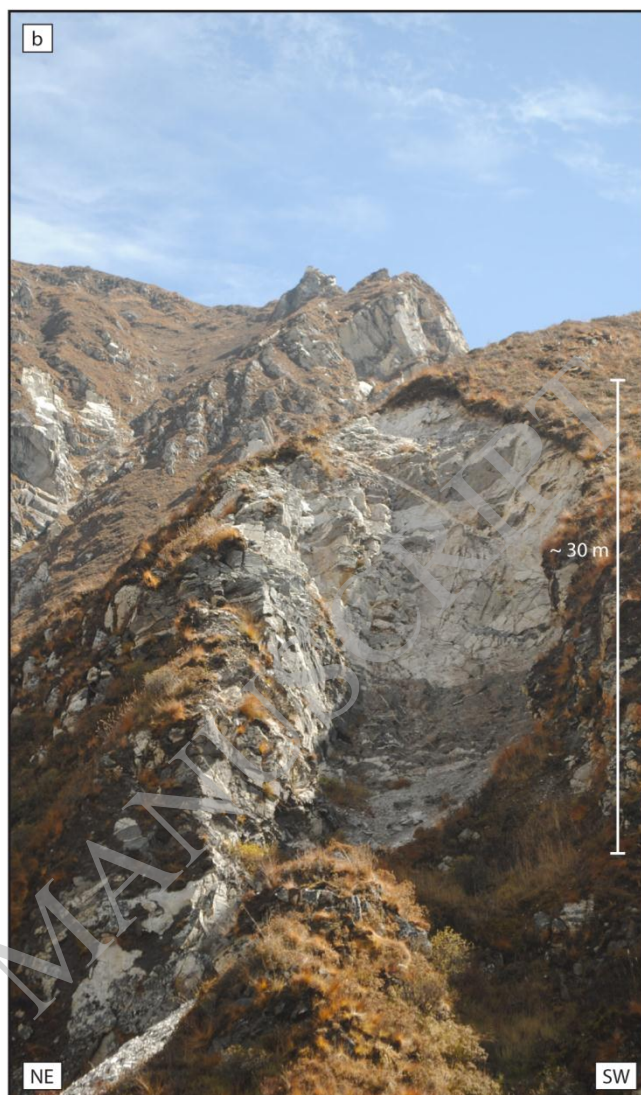
Fig. 4. (a) Example material of unit 3, a leucogranite with large, 1 – 5 cm, crystals of tourmaline, termed here as the Langtang formation. **(b)** A typical rockfall found in the eastern, higher elevation portions of Langtang Valley, with large intrusions of leucogranite within the bedrock of the scar. **(c)** Example material of unit 4, a finer grained, 0.25 – 1 cm, biotite, plagioclase, muscovite, quartz, semi-pelite schist, termed here as the Lower Tsergo Ri Formation.

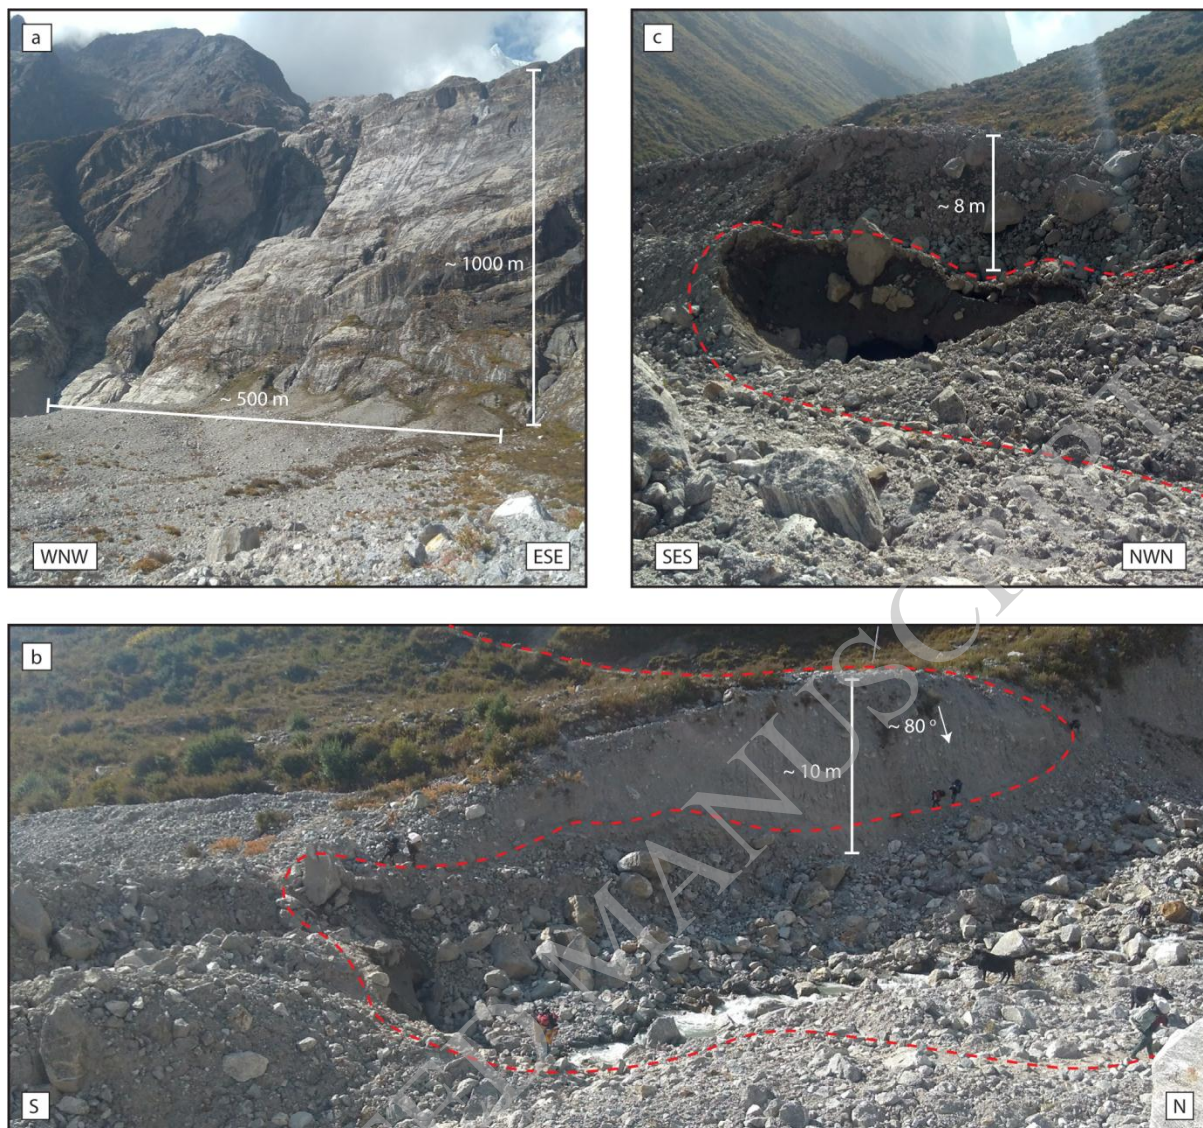
Fig. 5. (a) Front view of the Langtang Avalanche. Note the clear striations on the relatively smooth back-scar and change in slope of the back-scar which is indicative of a rotational element of movement. **(b)** A section of the Langtang Avalanche deposits that have been incised by a river. The precarious location of the new trekking route is shown by the red-dashed line. **(c)** A tunnel incised underneath the landslide deposits by a river. Red line indicates the current position of the trekking path over the top of the tunnel.

The Langtang Avalanche is perhaps the most renowned coseismic landslide to have occurred during the Gorkha earthquake, having entirely destroyed the village of Langtang with the loss of at least 300 lives. This event was a complex compound occurrence that began when earthquake strong ground motion caused a portion of glacial material within an ice-carved hanging valley, as well as a portion of bedrock approximately 500 x 1000 m in size (Fig. 5a), to collapse (Nagai *et al.* 2017). The deposits from this event have been previously estimated through remote sensing techniques to have a depth of ~60 m, an area of 0.63 – 0.88 km², and a volume of 5.51 – 9.66 x10⁶ m³ (Lacroix 2016; Nagai *et al.* 2017). Pertinent to this study is the interaction between the landslide deposits and trekking paths. This

event completely buried a ~ 500 m long section of the main trekking path, which has since been reinstated over the landslide deposits. The material within the deposits is mostly gneisses (unit 2) and leucogranites (unit 3). Fig. 5b shows the position of the new trekking path at the point where a river has incised through the deposits. The path here is highly precarious, with some sections < 30 cm wide beneath a > 80 °, 10 m high slope of loose deposits, which are vulnerable to movement during a future trigger event. Furthermore, the path crosses over a narrow tunnel that has been created by the river (Fig. 5c). This portion of the deposits is unstable, and several boulders were witnessed falling from beneath the tunnel into the river. This demonstrates that the Langtang Avalanche is continuing to impact the safety and vulnerability of Langtang's trekking paths more than three years since the initial failure occurred.

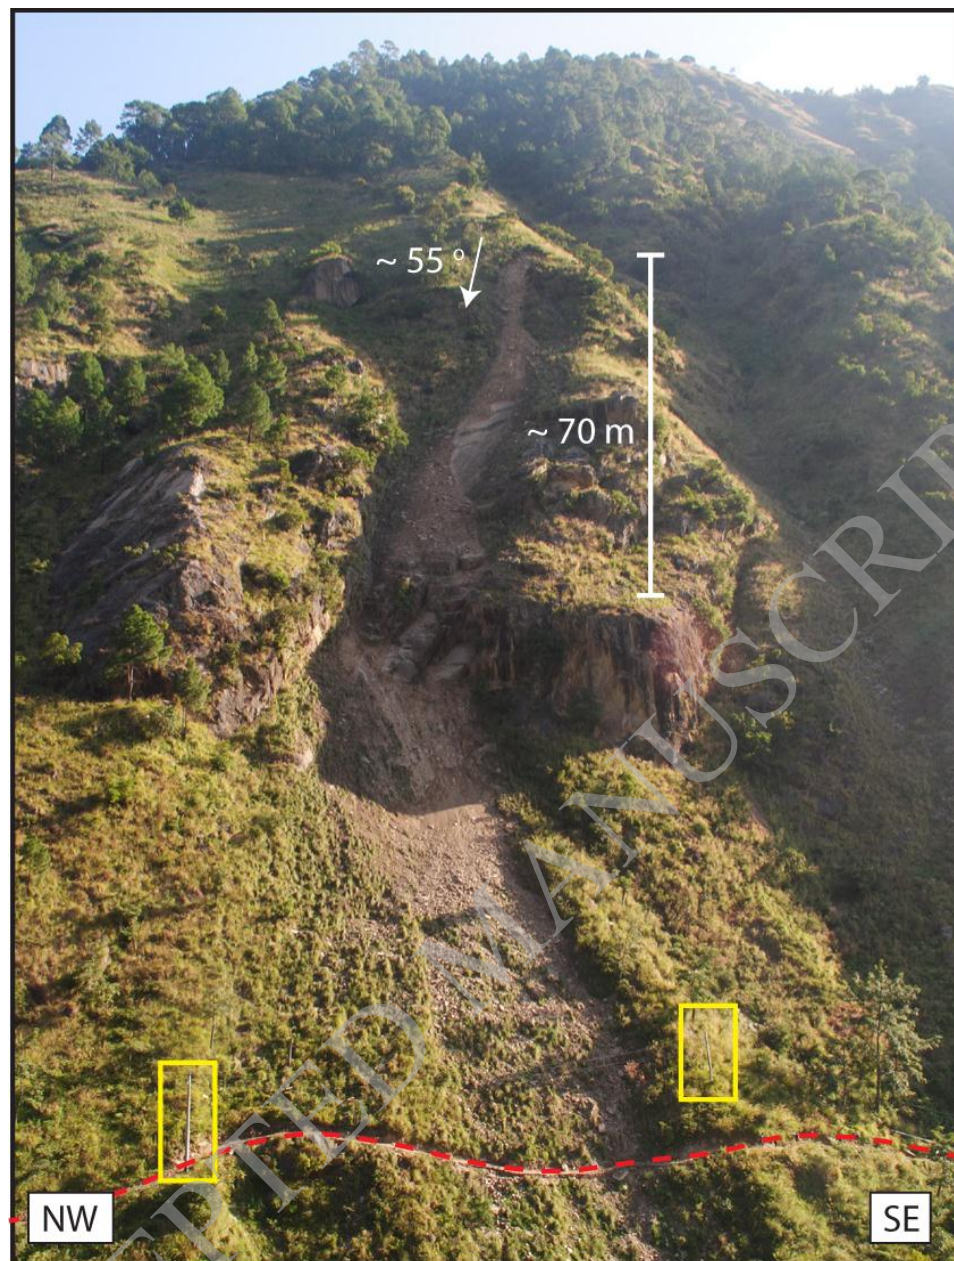
Fig. 6. Debris slide located ~4 km east of Syraprubesi. Red-dashed line indicates the main trekking path that has been impacted by the failure. The yellow boxes indicate the position of electricity / telegraph poles.

Whilst the Langtang Avalanche has undoubtedly had the greatest single impact on trekking infrastructure, the cumulative impacts of smaller, but more widespread, coseismic failures cannot be understated. For example, coseismic debris slides were pervasive along the lower, western portion of the valley. Fig. 6 shows a debris slide that initiated near the ridgeline of a > 55° hillslope covered by grassland in the lower slopes and trees and larger shrubs in the upper slopes. The bedrock geology of the scar of this failure is dominated by the gneisses of unit 1. However, as the failure is shallow (< 0.5 m), and has mostly disturbed the unconsolidated regolith material overlying the bedrock, it is defined as a debris slide rather than a rockslide. In terms of impact on trekking infrastructure, the localised runout of this failure resulted in only a small volume of material intersecting the path. However, more concerningly, it was observed that this debris slide came close to damaging several electricity pylons. These pylons connect to the new hydropower station near Kyanjin Gompa, and are a vital component of Langtang's energy infrastructure.

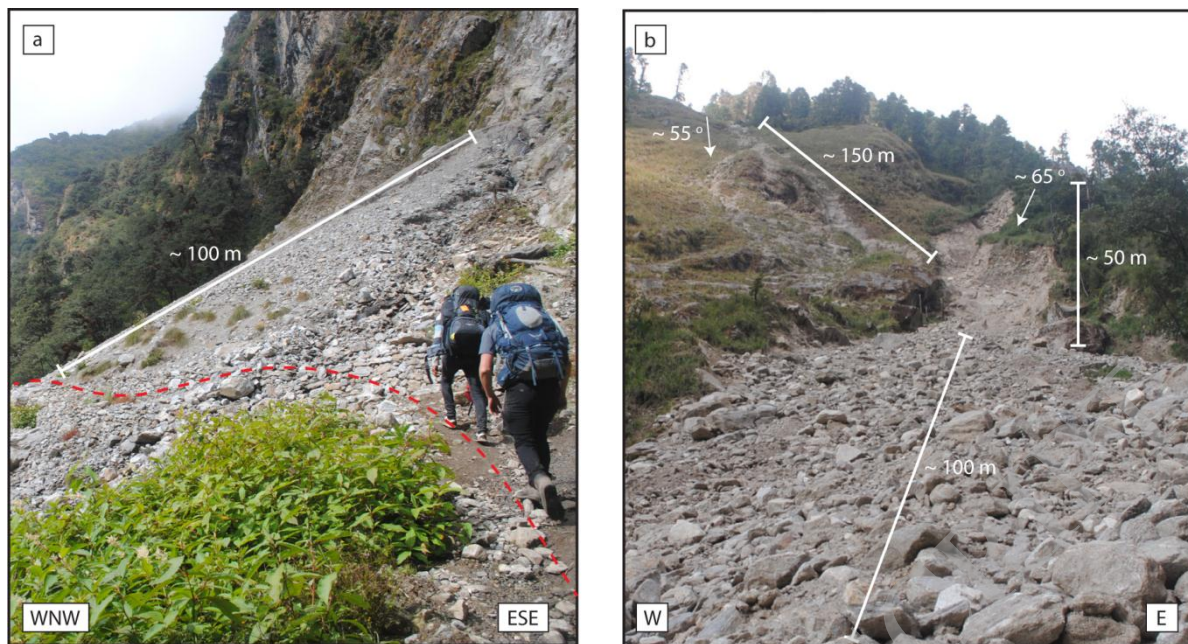
Fig. 7. (a) Debris fan of an unconstrained rockfall located ~ 4 km west of Thangsyap, which has intersected the trekking path (red-dashed line) below. **(b)** Debris fan of material from a debris flow and rock/debris fall that also intersected the trekking path (from where this photo was taken).

Unconstrained rockfalls were frequently observed to bury the main trekking route. Fig. 7a shows an example of such an event. The material in the deposits confirm that this failure occurred within the bedrock itself, which was composed of the unit 1 gneisses. The material from this failure buried a 30 m long segment of the trekking path, reportedly killing 30 people. This landslide demonstrates that even relatively small-scale events have the potential to cause loss of life when hazard overlaps with vulnerability. Since the initial failure, a new trekking path has been re-dug through the deposits, with no attempt at any mitigation against potential monsoonal reactivation of debris material. As such, this section of the path should be considered at high-risk of being damaged or blocked by reactivated landslide material in the future. Fig. 7b shows a debris fan from a combined rock/debris fall and a rock/debris flow. The source zones for the flow and the fall appear to be at major $> 55^\circ$ and $> 65^\circ$ breaks in slope. The path of the flow appears to have been controlled by the existing hillslope morphology, with a knoll splitting the flow into two channels just before the main rockfall debris fan. The flow travelled for ~200 m before joining the main debris fan, whilst the debris from the main rockfall travelled ~100 m. This failure totally buried a ~40 m section of the trekking path, and is reported to have killed 20 people. Similar to the previous examples, the position of the new trekking path now lies on top of the landslide deposits, with no measures aimed at moderating future instability. As such, this section of the path is again considered to be at high risk of being blocked, or otherwise impacted, by future reactivation of landslide debris.

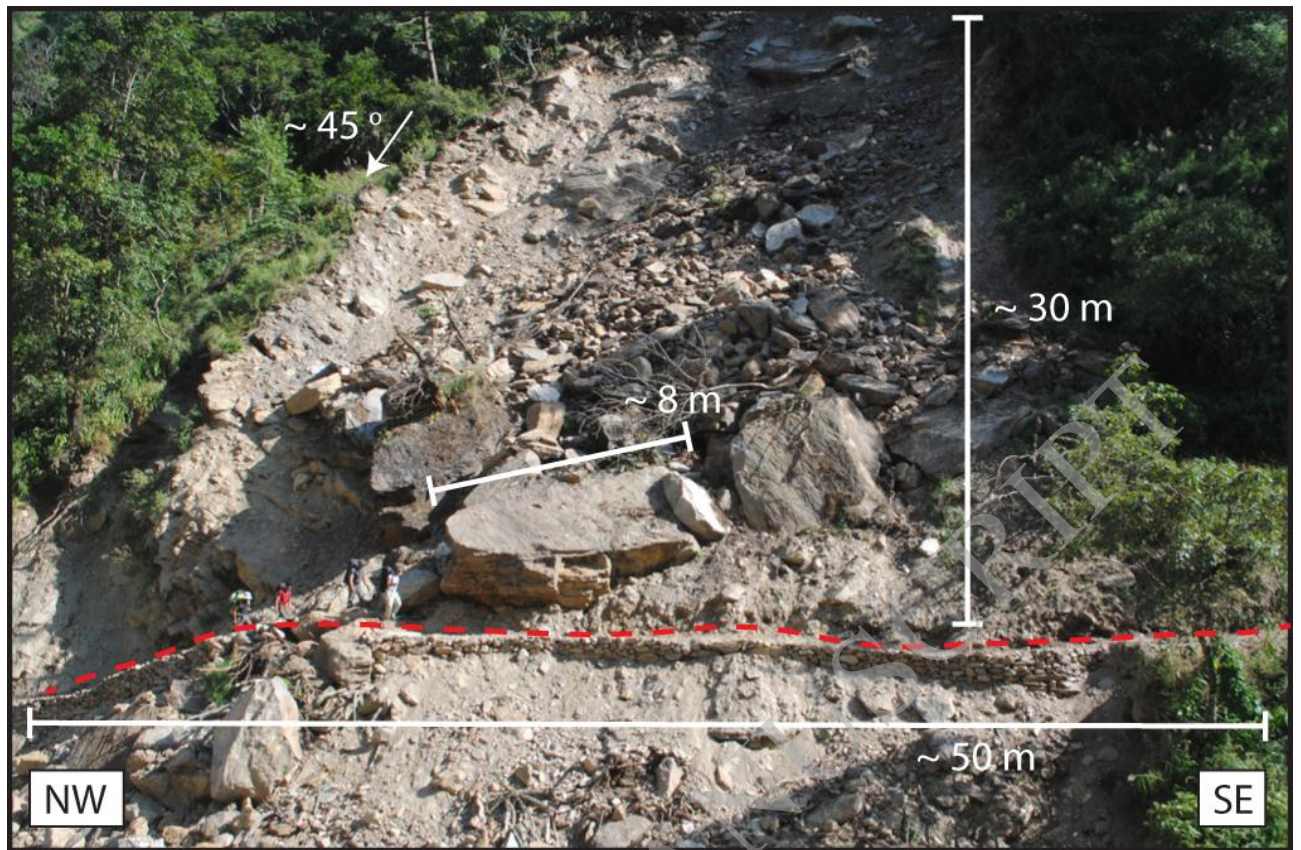
Fig. 8. Monsoon-triggered translational slide located 2 km east of Syraprubesi. A new trekking path (red-dashed line) has been constructed through the deposits, yet many large unstable boulders remain above the path.

As well as coseismic landslides, monsoon-triggered landslides were frequently observed across the valley, and care must be taken when distinguishing between these different triggering mechanisms. Fig. 8 shows a typical monsoon-triggered translational debris slide that has occurred on a forested, $> 45^\circ$ hillslope. This slide has a height of ~30 m, and completely destroyed an ~45 m wide section of

the path below, which has since been re-built. The sides of the new path have been supported with small, < 0.5 m high walls of unconsolidated debris material. The debris material remaining above the new path is highly unstable, with several (> 10 m wide) blocks balancing within the deposits. This material will be highly susceptible to movement during subsequent monsoon-seasons, and as such remains at-risk of impacting the trekking path further.
